LABORATORY ACTIVITIES RELATED TO MARINE CORROSION: SEARCH FOR DAMAGES CAUSES

C. Dellabianca, L. Rolla, V. De Luise

C.T.S. Centro Tecnologico Sperimentale S.r.l., 19020 Ceparana, (SP) – ITALY
e-mail: ctssp@ctssp.com Web: www.ctssp.com

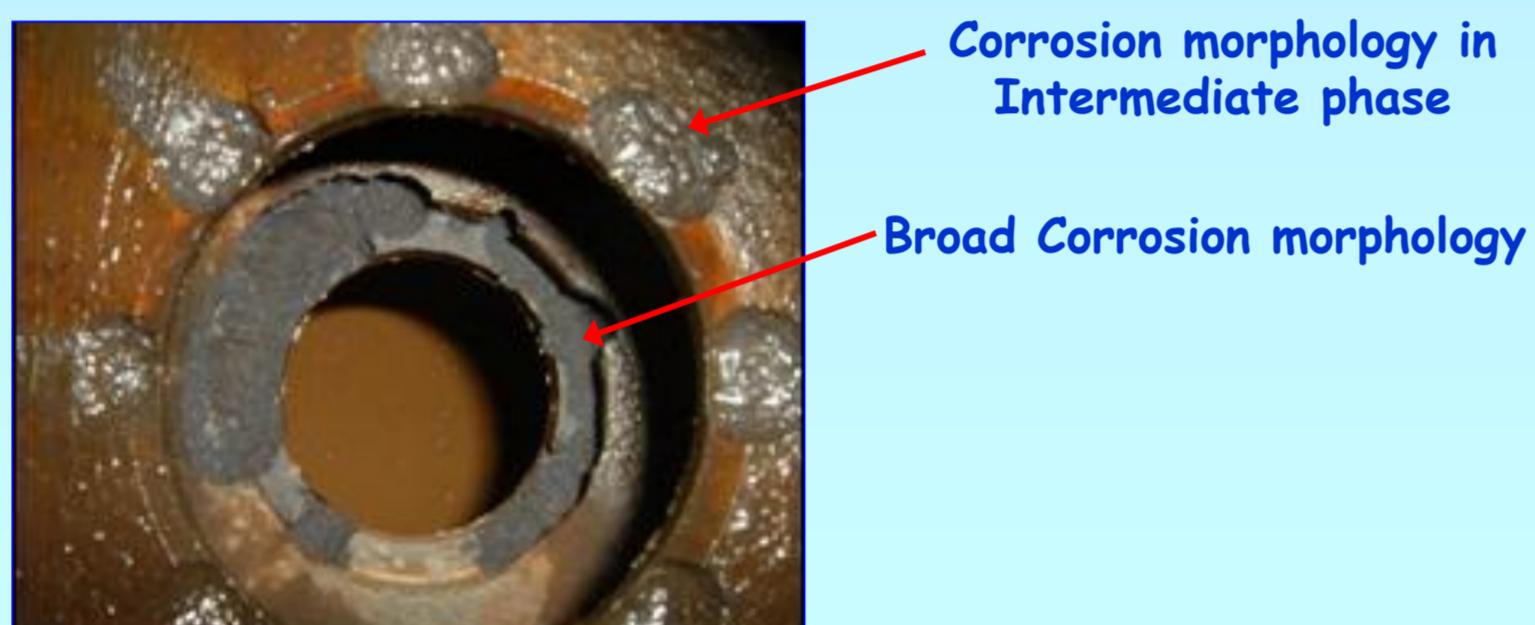
Damage: Corrosion developed on pump cover of aluminium alloy in correspondence to thermostatic valves

FAILURES CAUSE: Corrosion erosion mechanism

Contact between two materials which the redox potential are located to the extreme of oxidation potential scale.

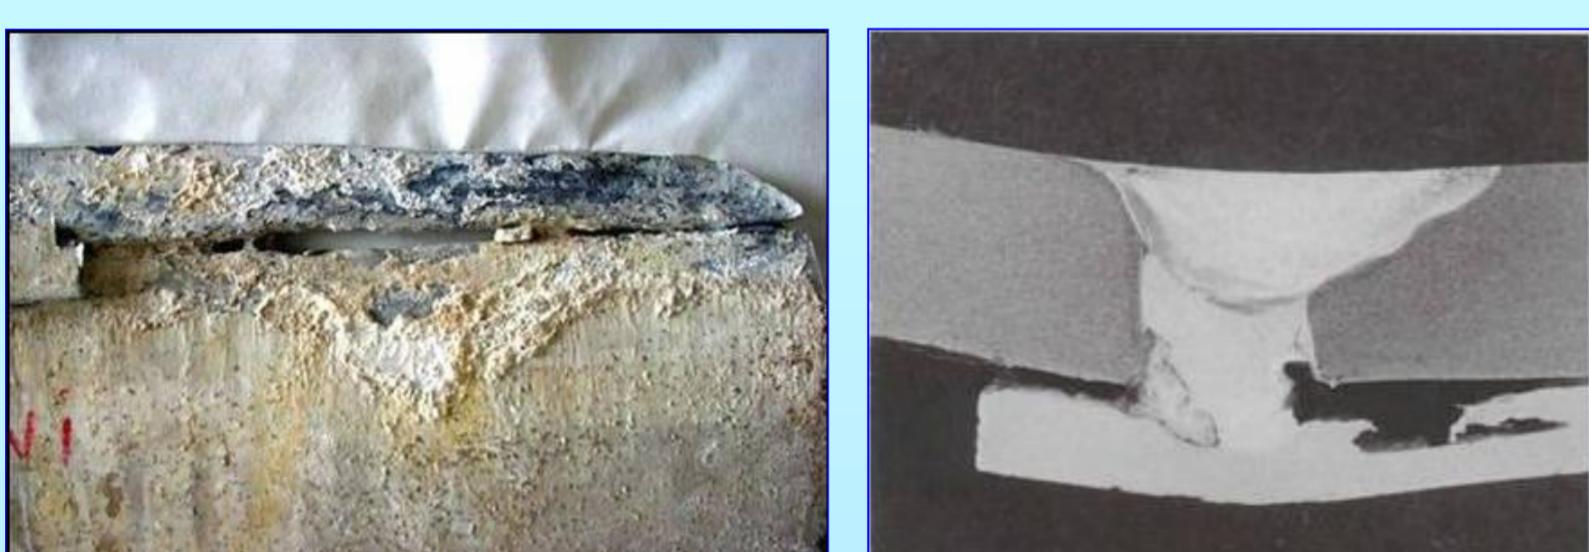
Macrographic examination:

Damage: a water leakage from the drift has been observed. The subsequent inspection showed a completely flooded area, covered by deposits and the welded joints completely corroded.

Crateriform morphology typical of a crevice corrosion located in correspondence of the interstice present at root of the welded joint between the weld metal and the backing strip material.

The macrographic examination (on a transverse section) after etching permitted to observe a significant asymmetry of the joint.

FAILURES CAUSES: Crevice Corrosion

- Low oxygenation conditions
- The sea water inlet in the drift, combined to the low oxygenation of the closed environment, has generated very aggressive conditions.
- The greater localization of the corrosion on the joints was imputable to the presence of narrow fissures and to the thermal conditions due to welding process which make the material most vulnerable to the oxidation trigger.

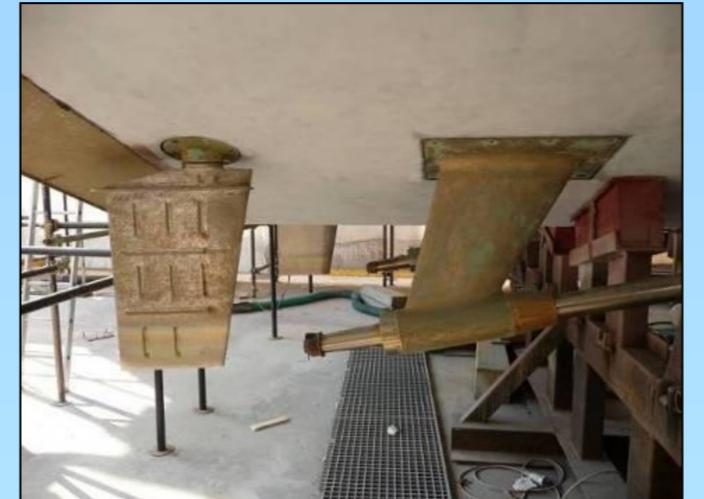
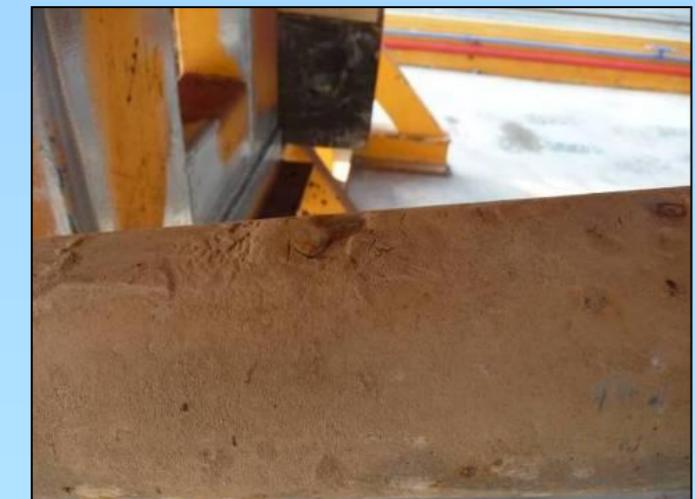
Conditions: The vessels were partially embedded in the mud have been covered by mud, due to a river flood.

FAILURES CAUSE:

Crevice Corrosion/MIC

Some bacteria which use iron in their food cycle (sulphate reducing bacteria) find in the mud the ideal conditions for their development. In this case, the observed colour variation are compatible with the proposed mechanism

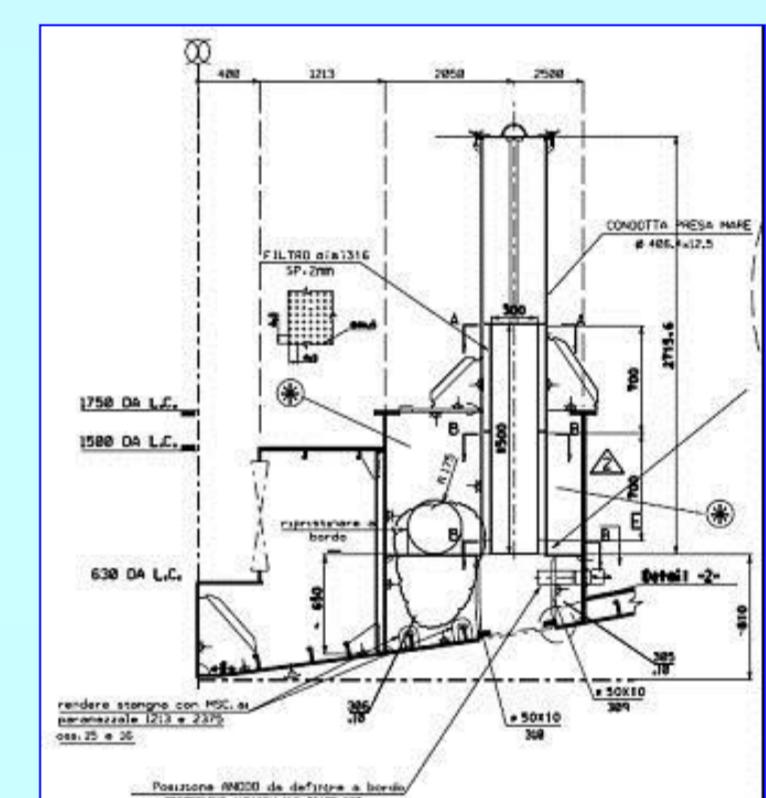
Apparatus: Cooling sea water intake with removable filter

- Pipe: carbon steel S355J2H (UNI EN 10210-1)
- Piping: copper-nickel alloy separated from the pipe by an austenitic stainless steel AISI 316L hub

- Antifouling protection of cooling line: Cathelco system which dissolves Cu ions at controlled rate
- Cathodic protection of Cu-Ni alloy with iron anodes inside the pipes

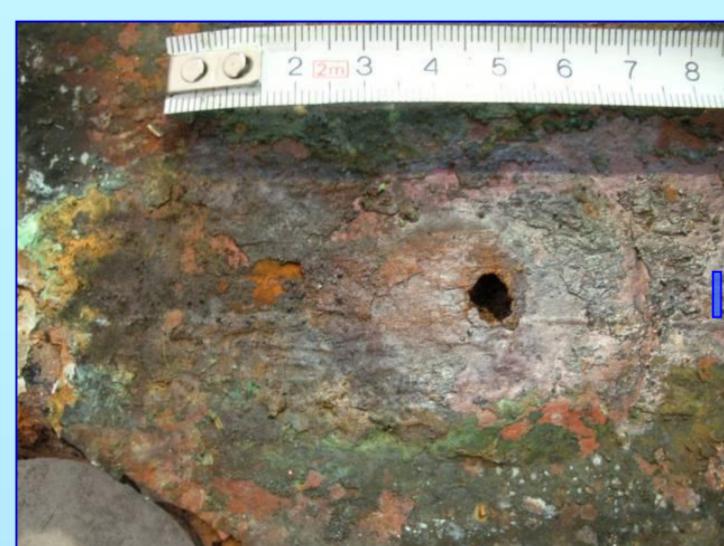
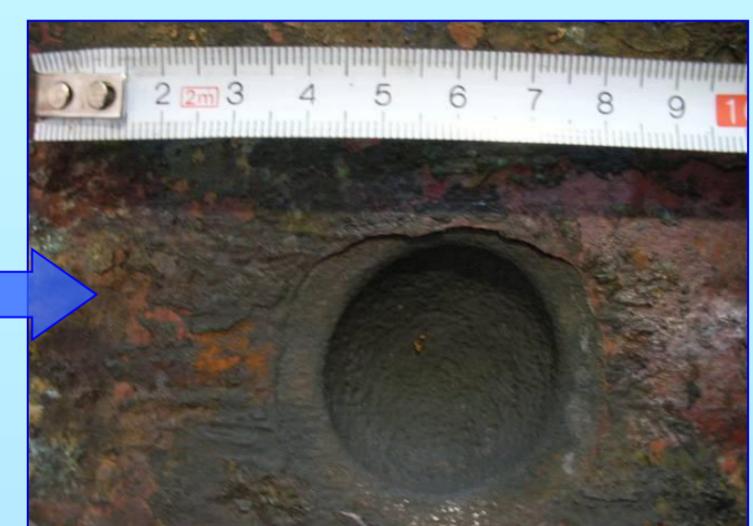
Damage: The carbon steel pipe was covered by deposits and seaweed: after the removal of the paint film, multiple pitting corosions and craters have been revealed.

Electric Potential Difference Measures:

Full protection for aerobic conditions (EN 12473 - 2000).

FAILURES CAUSES:

- Stagnant conditions (possibility of anaerobic conditions)
- Anti-fouling not able for full protection in anaerobic conditions (-900 mV, EN 13473)
- The extensions of oxides and deposits on anodes surfaces was a minimizing factor for cathodic system efficiency
- Poor protection of the steel surface (poor paint film)
- Wide cathodic area (filter in stainless steel) stimulate the increase of corrosion rate in the anodic areas developed in the paint film lacunas.
