# Laboratory activities related to marine corrosion: search for damage causes

C. Dellabiancia, L. Rolla, V. De Luise, S. Rinoldi, M. Dellabiancia  
C.T.S. Centro Tecnologico Sperimentale S.r.l. Ceparana (SP)  
[ctssp@ctssp.com](mailto:ctssp@ctssp.com) - [ctssp.dir@ctssp.com](mailto:ctssp.dir@ctssp.com) – [www.ctssp.com](http://www.ctssp.com)

## • CASES OF STUDY

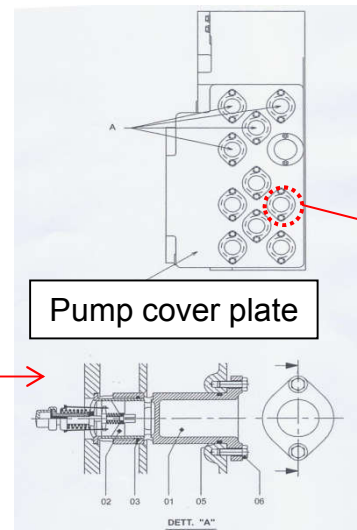
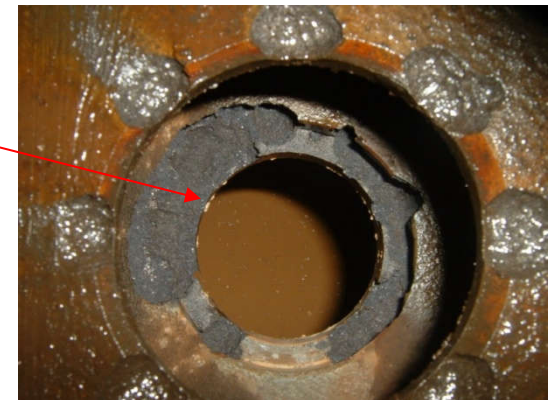
The corrosion phenomenon documented on board of the four vessels has been localised in two main positions

- Contact position between the aluminum cover plate and the thermostatic copper alloy valve
- Portions of the recirculation cooling system where the light alloy components were close to recirculation pumps realized in cast iron

The investigated corrosive attack was definitely enhanced and accelerated by the direct contact of materials defined by extremely different electrochemical potentials. On the top of it the Al light alloy typically suffer of crevice corrosion phenomenon, in position where the aeration is then strictly reduced, as for the corroded components installed by the recirculation pumps.

**Recommended solution ➔ Substitution of Al-alloy, implementation of proper isolating system**

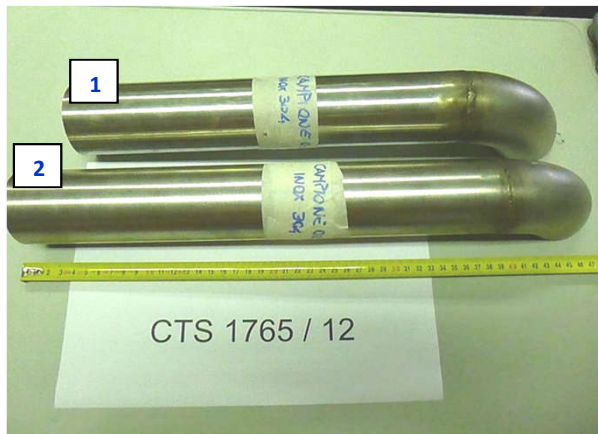
AISI 304L samplings from the onboard installation

Appeared affected by severe localized pitting corrosion attack close to the longitudinal welding as well as a more diffused phenomenon, generally observed on the lower internal surface of the pipes, where conditions such as stagnant coolant and corrosion deposits may have enhanced the corrosion rate.

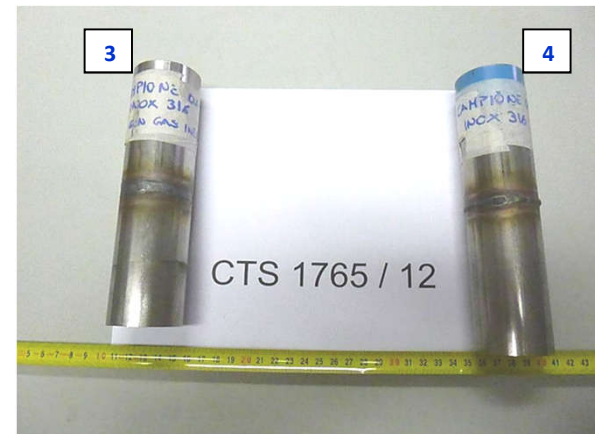
AISI 316L samplings from the proposed repairing

Characterized by serious welding operating defects, like the lack of penetration and fusion as the improper backing gas protection and the heat tint colour, due to an incorrect setting of the welding parameters. This conditions induced a geometrical non-uniformity and the precipitation of carbides, both responsible for the eventual reduction of the corrosion resistance of the material.

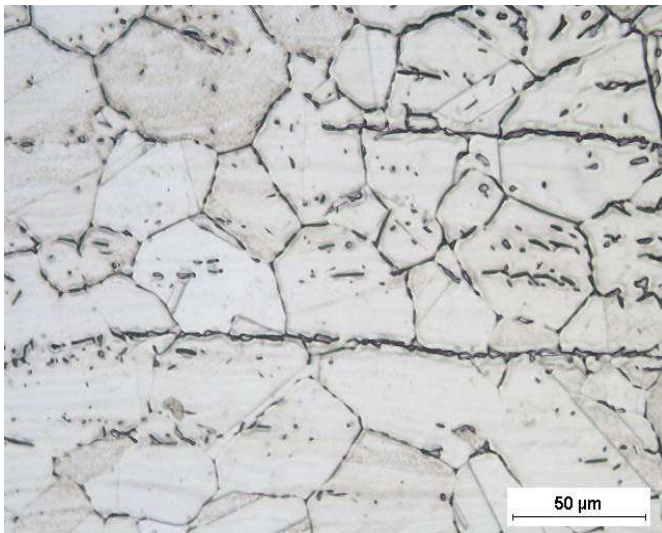
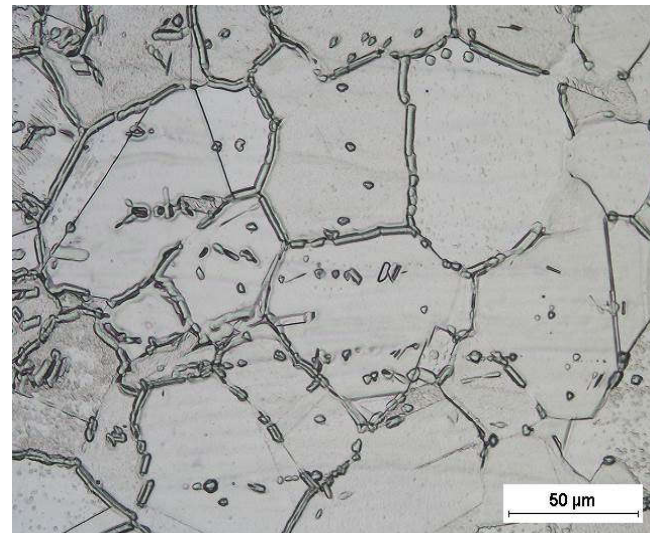
Samples number 3 and 4 (AISI 316L) have been prepared in order to inspect the microstructure, specifically focusing on positions close to the welding joints.

➔ In these areas, especially in the heat affected zones, was clearly evident a **diffused precipitation of carbides at the grain boundaries** so to characterize the consequent **sensitization phenomenon** enhancing the intergranular corrosion chances

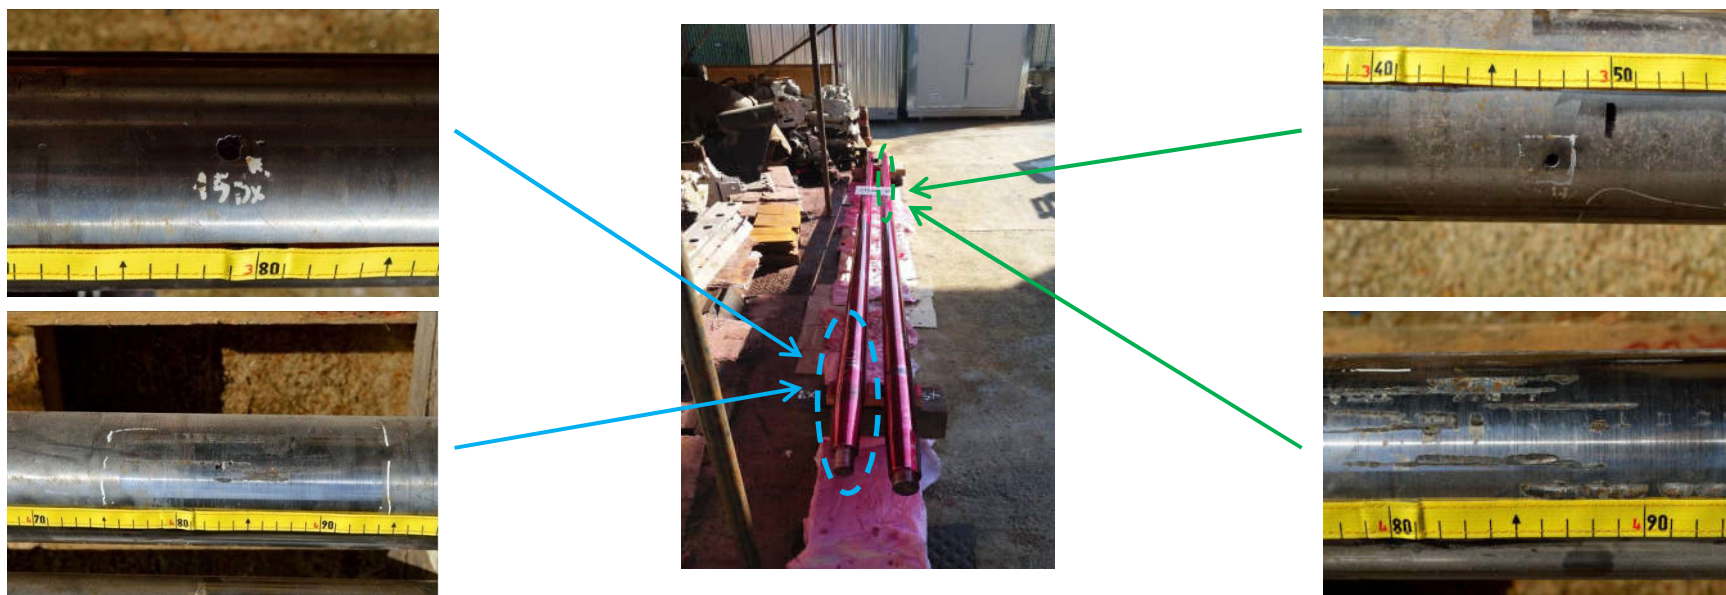
The two shafts appeared affected by both **localized pitting** corrosion phenomena and **crevice** one. Considering the technical description of the engine on-board installation, the most of the corrosion attack was observed corresponding to the **inboard portion** of both the components.

The martensitic stainless steel 17- 4PH, as generally all the stainless steel, suffers **severe crevice corrosion effects** in case of **scarce aeration** and particularly when the **component** is kept **steady in stagnant liquid** and a thin liquid layer is preventing its natural passivation process.

**Periodical rotation and motion of the shafts  
Adequate and supplementary prevention system**

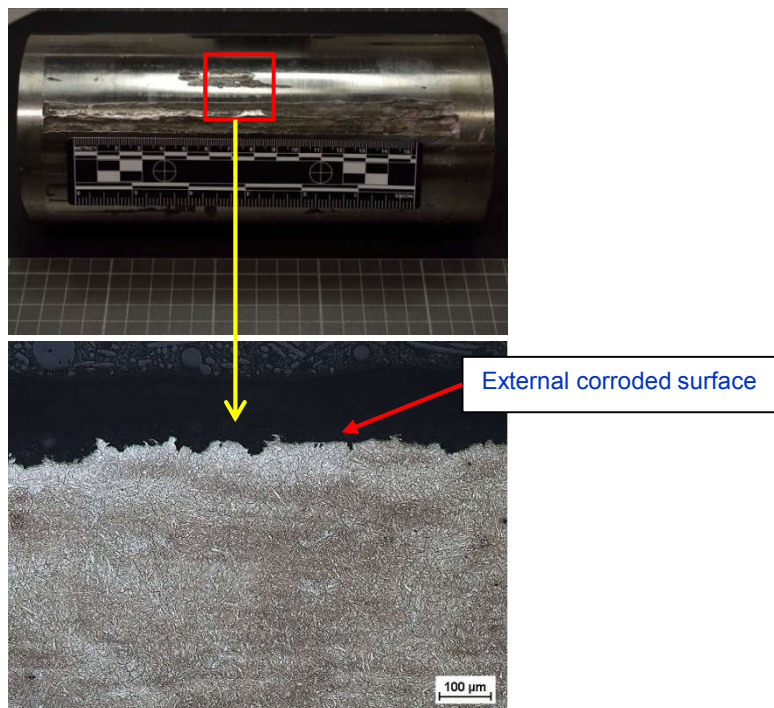
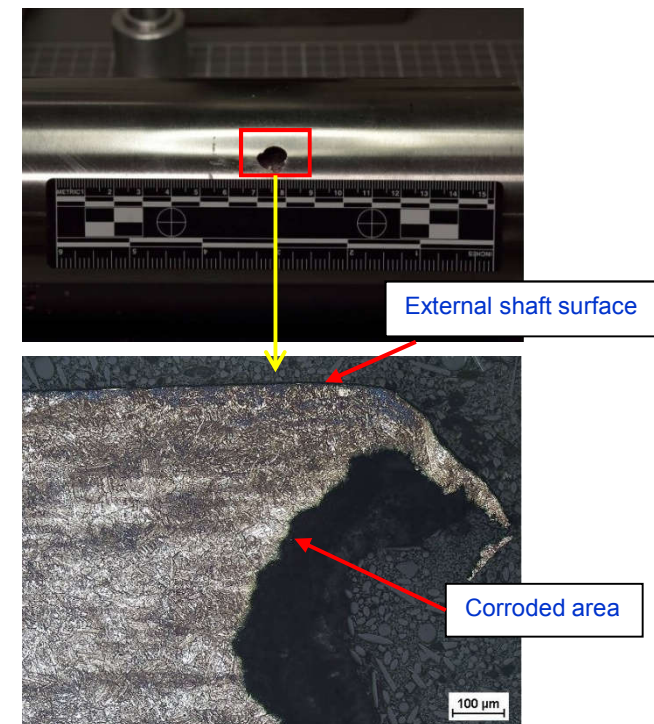
The surfaces morphologies of two specifically identified sections, one on a corrosion pit and the other on a crevice affected zone, have been inspected to better determine and check the metallurgical state of the material.

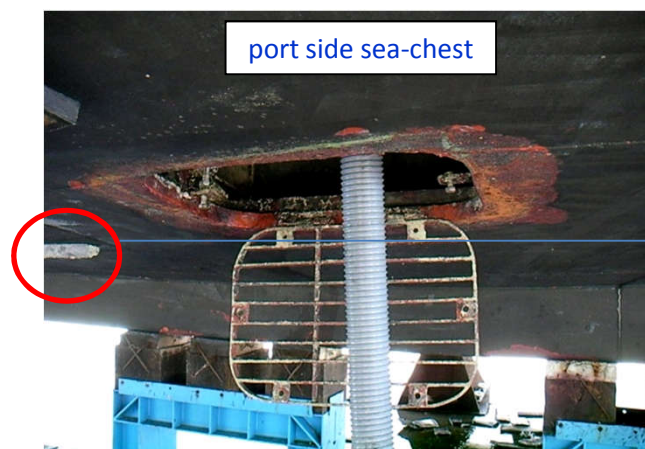
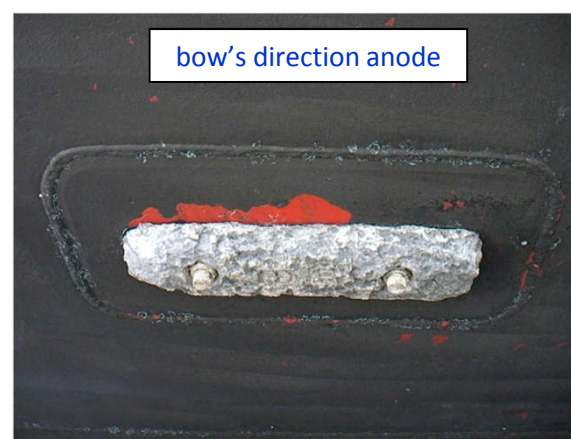
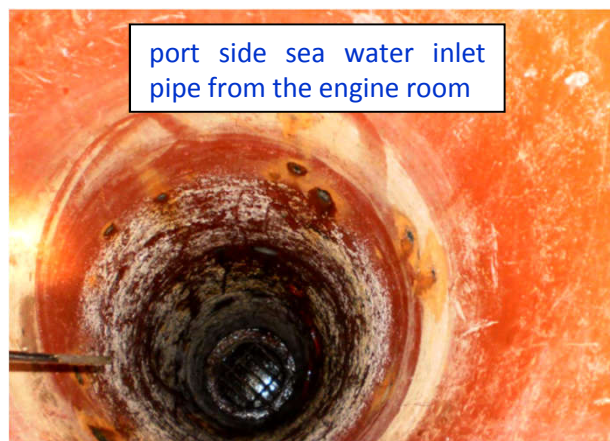
The anodes were electrically connected to the hull, as tested with ASITA MD533 tester. The portion of oxide and fouling scale wasn't conductive. The on board equipment on engine room were generally electrically grounded to the hull. In particular a wiring connection was realized between the main electric box and all the flanges of cooling systems were connected with copper plate.

On the basis of the obtained results the most probable corrosion scenario was a **poor protection of the steel** (locally poor paint film, poor cathodic protection in the higher pipe portion), **stagnant condition** (may be anaerobic) and the **presence of a large stainless steel cathodic area** (the filter section) that induced a galvanic corrosion phenomenon localized on little anodic areas, portion of the hull where vacancies of the paint layers were highlighted, reducing the overall corrosion resistance of the structure.

**Realization of a good paint substrate**  
**Proper cathodic protection on the higher pipe portion**  
**Eliminate the electrical connection between stainless steel filters and the mild steel piping**

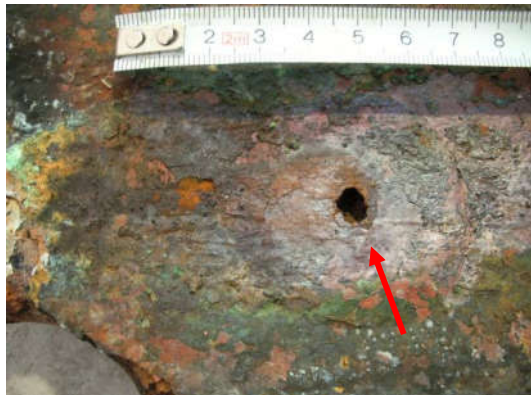
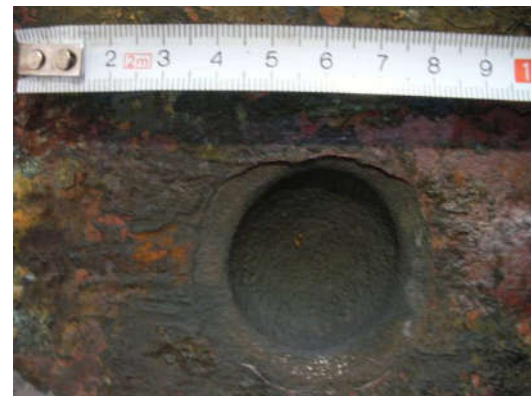
- The six different portions of the sea water piping have been visually examined and the crater shaped pitting holes were dimensioned and documented, as well as the conditions of the sampled zinc anodes

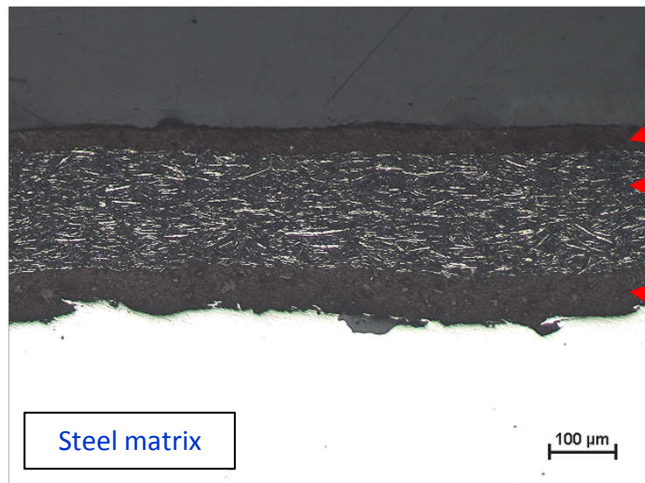
On the internal surface was documented three different paint layers  
The **first layer** is the one directly in contact with the steel (**57µm**) which is the **shop primer**, the **second** one (**188µm**) which is corresponding to the **zinc reach barrier coating** then the **last coating level** is the outer one (**32µm**) and ascribable to the **red primer** finishing deposition

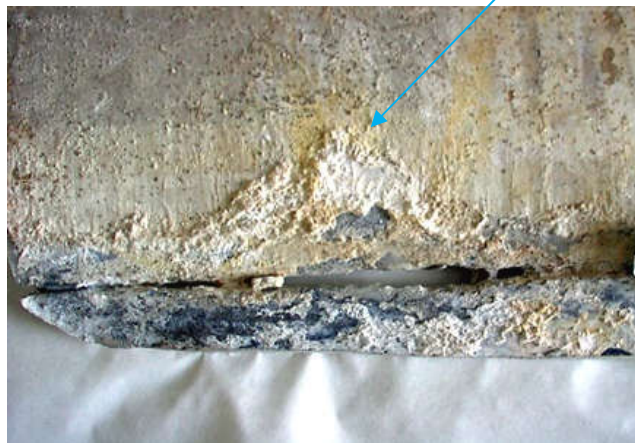
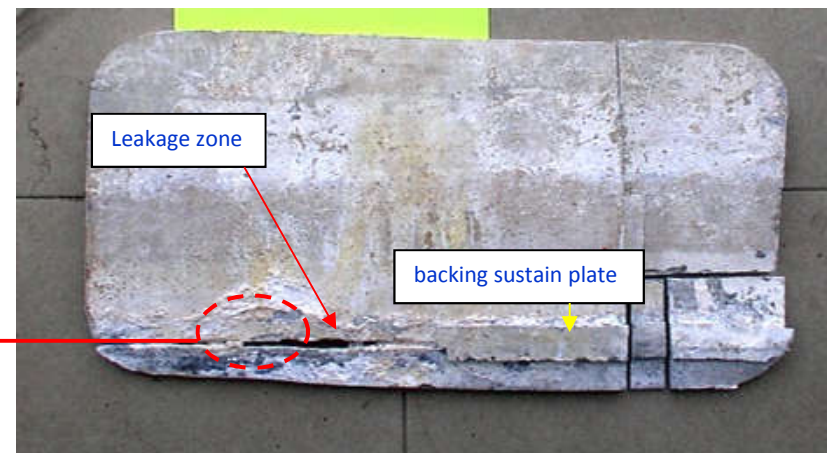
The hull's plate appeared seriously deteriorated. Close to the weld position were observed diffused and clear **evidences of white and grey solid deposits** fully resembling Al oxides

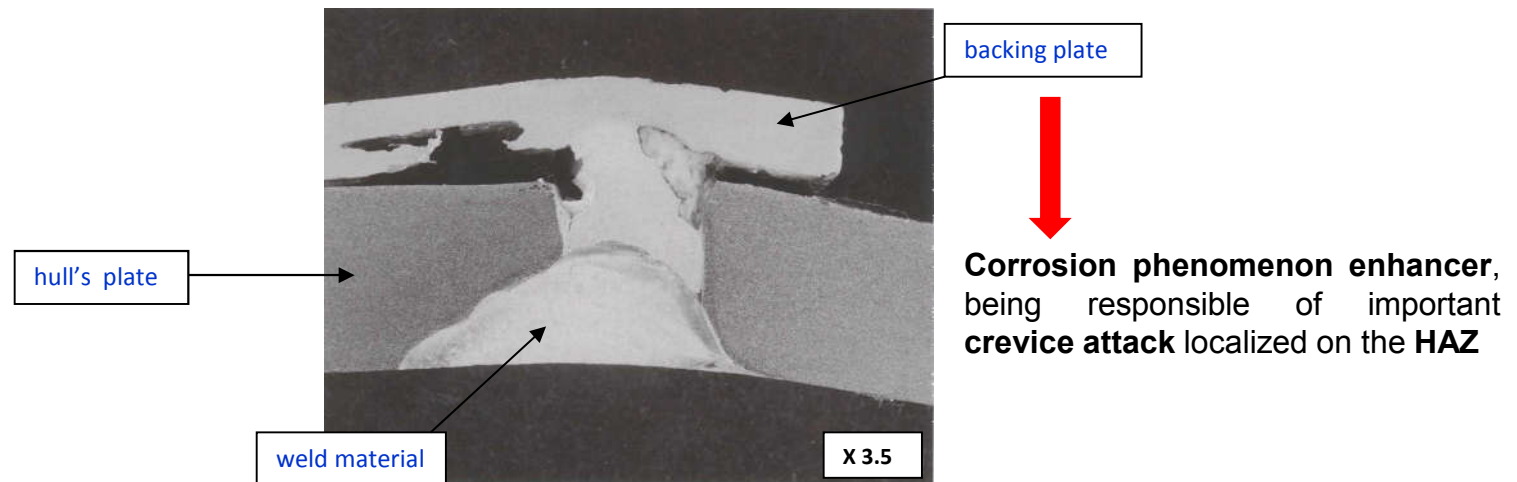
Light alloy metallurgically suffer **operating conditions and geometrical applications in which a proper aeration is not ensured**. In case of rupture or damaging of the natural self protecting oxide layer and being impeded its natural restoring process (lack of proper oxygen concentration flow) the material is then openly prone to corrosion attack. In the specific case the severe sea water leakage through the hull's damaged plate, combined with the extremely limited aeration conditions of the failed section (ballast tank) induced the generation of an highly aggressive environment for the Al-alloy structure.
