LABORATORY ACTIVITIES RELATED TO MARINE CORROSION: SEARCH FOR DAMAGES CAUSES

C. Dellabianca, L. Rolla, V. De Luise

C.T.S. Centro Tecnologico Sperimentale S.r.l., 19020 Ceparana, (SP) – ITALY
e-mail: ctssp@ctssp.com Web: www.ctssp.com

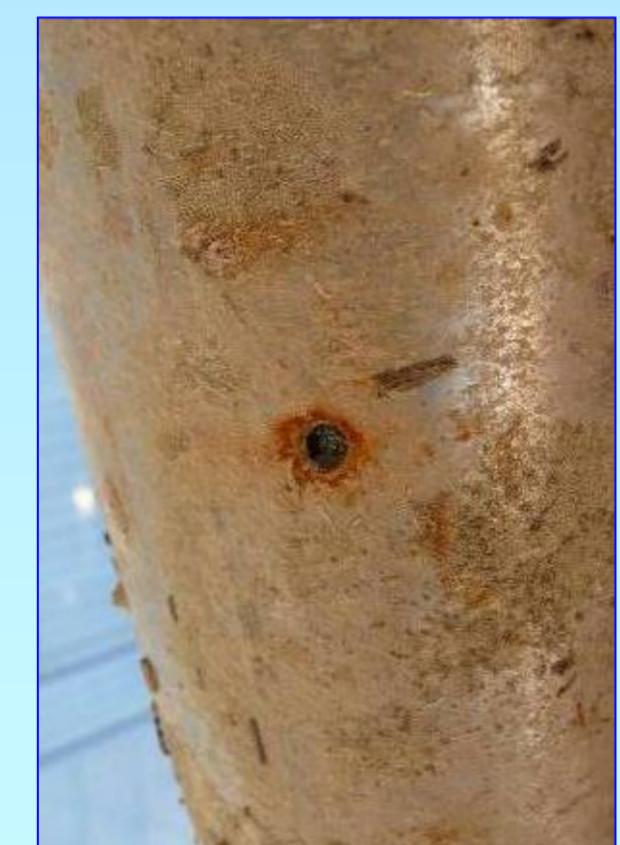
Damage: The carbon steel pipe was covered by deposits and seaweed: after the removal of the paint film, multiple pitting corosions and craters have been revealed.

- Stagnant conditions (possibility of anaerobic conditions)
- Anti-fouling not able for full protection in anaerobic conditions (-900 mV, EN 13473)
- The extensions of oxides and deposits on anodes surfaces was a minimizing factor for cathodic system efficiency
- Poor protection of the steel surface (poor paint film)
- Wide cathodic area (filter in stainless steel) stimulate the increase of corrosion rate in the anodic areas developed in the paint film lacunas.
