# Laboratory activities related to marine corrosion: search for damage causes

C. Dellabiancia, L. Rolla, V. De Luise, S. Rinoldi, M. Dellabiancia  
C.T.S. Centro Tecnologico Sperimentale S.r.l. Ceparana (SP)  
[ctssp@ctssp.com](mailto:ctssp@ctssp.com) - [ctssp.dir@ctssp.com](mailto:ctssp.dir@ctssp.com) – [www.ctssp.com](http://www.ctssp.com)

## • CASES OF STUDY

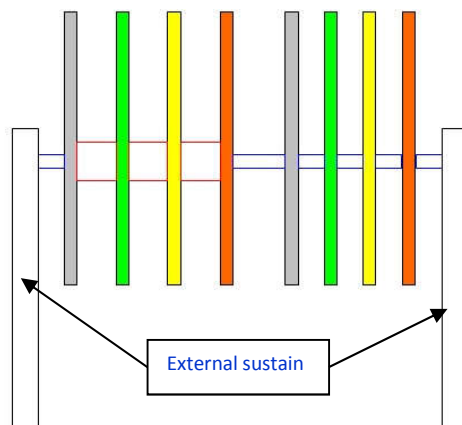
- Inductively coupled plasma atomic emission spectroscopy (ICP-AES) → Conducted on 5 cooling water samplings, addicted with anticorrosion product adopted on-board, inspecting for metallic particles or intermetallic compounds ascribable to possible causes of the documented damages
- Comparison of two protective additives (NALCO 2536 plus – UNITOR COOLTREAT AL) used in the cooling system simulating operating on board conditions and evaluating the corrosion rate on the tested samples according to ASTM D1384 – 05 (Standard Test Method for corrosion test for engine coolants)

→ Tested solutions @  $88 \pm 2^\circ\text{C}$ , with  $100 \pm 10$  ml/min of aeration for 336 hrs

NALCO 2536 PLUS 2% and 100 ppm of mixture of sulphate, chlorides and bicarbonate

UNITOR COOLTREAT AL 5% and 100 ppm of mixture of sulphate, chlorides and bicarbonate

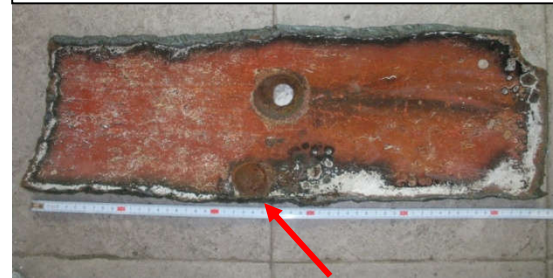
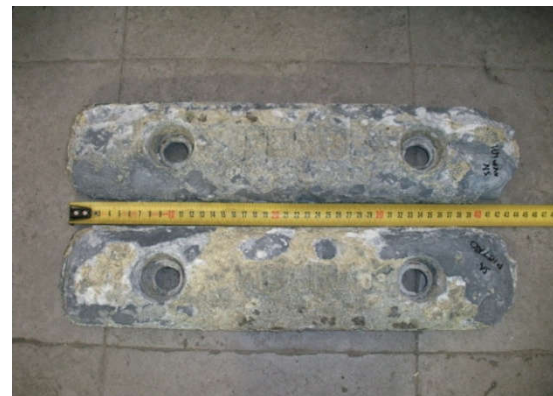
- Portion of the pipe dedicated to the sampling for chemical, mechanical and microstructure analysis
